## New Generation of Fire Hydrants Secure Against Multiple Threats

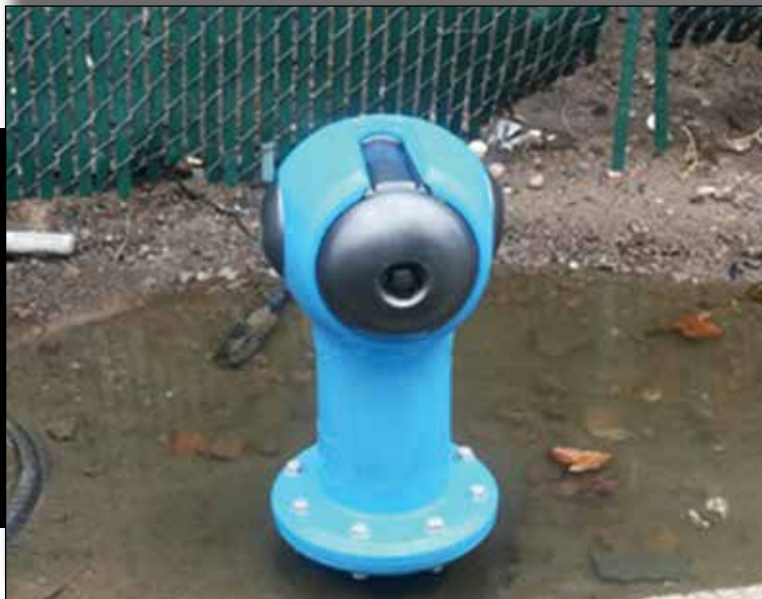
This fire hydrant is designed to withstand harsh coastal conditions and deter would-be vandals.

The first thing LBWD's superintendent Chris Windle noticed about this hydrant was that it looked different (see the photograph above). The operating nut, which typically protrudes from the top of the hydrant, was not exposed but rather shielded inside the hydrant body. This feature not only

helps prevent the nut from being stripped by vandals using the wrong type of wrenches; it also provides an added layer of security to the system by limiting access to the water supply to authorized personnel only. The pumper nozzle and side caps were also redesigned to have no protruding nuts or chains, leaving fewer hydrant parts exposed and vulnerable to unauthorized users as well as the harsh coastal environment.
